FULL SCALE TECHNOLOGY DEMONSTRATION OF A MODERN COUNTERROTATING UNDUCTED FAN ENGINE CONCEPT

ENGINE TEST

December 1987

by
GE Aircraft Engines
GE36 Project Department
Cincinnati, Ohio 45215

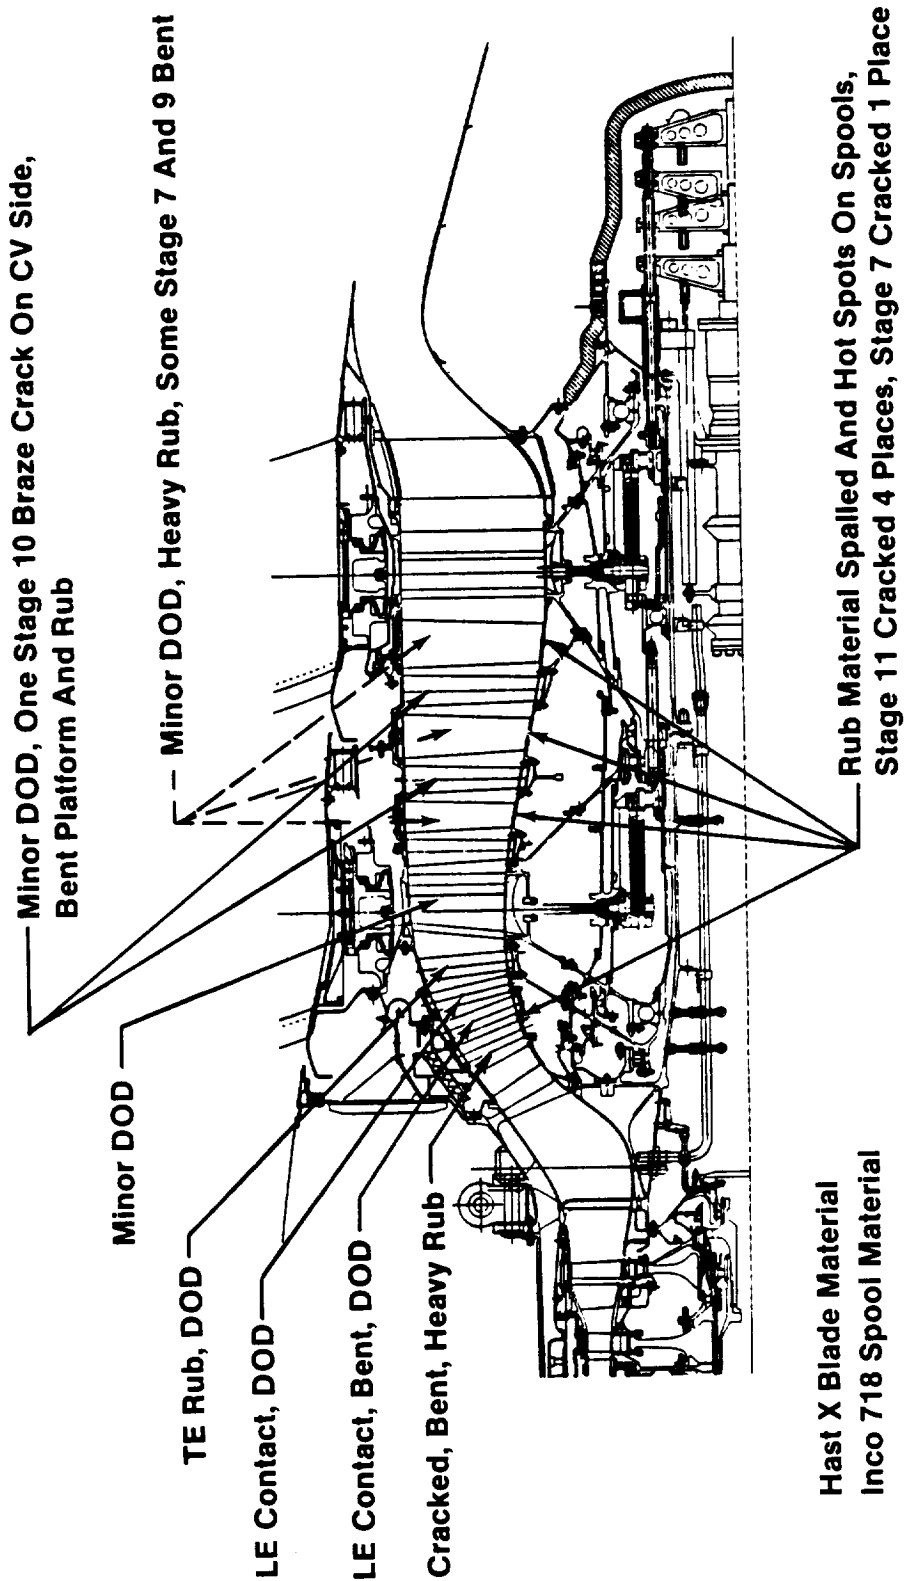
Figure 3-11. Summary of Hardware Damage.

Figure 3-11 shows a diagram summarizing the hardware damage.

During testing, prior to the stall, significant first flexural vibratory response had been observed on all stages of power turbine blading (Figures 3-12 and 3-13). Teardown revealed significant damage to Stage 1. Several blades had large leading edge root cracks and were leaning aft toward Stage 2. One local segment of blades was buckled aft into Stage 2. All Stage 2 leading and trailing edges, as well as all Stage 3 leading edges, were bent circumferentially and severely rubbed. Stages 1, 7, 9, and 11 exhibited severe tip rub. While Stages 7, 9, and 11 had rubbed previously during Build No. 1 due to oil leakage past a broken carbon seal, the poststall rubs were more severe. Stage 4 had very light tip rub only at the trailing edge. Stages 2, 3, 6, and 8 exhibited no tip rub. Stage 10 rubbed only one blade, which was bent at the platform. Stages 7, 9, and 11 had several bent airfoils. The rotor inner

spools exhibited local burn spots at Stages 1, 7, 9, and 11 rub locations, with cracking evident at Stages 7 and 11. Domestic object debris damage was confined to the power turbine flowpath. Nicks and dents were significant only on the forward turbine blade stages. The power frame and OGV (outlet guide vanes) airfoils exhibited only minor debris damage.

Metallurgical evaluation of the Stage 1 blades found root leading edge cracks on 117 of 124 airfoils. However, none of the airfoils were completely separated. Crack lengths varied from approximately 0.02 to 1.2 inch. SEM (scanning electron microscopy) revealed evidence of high cycle fatigue along the entire fracture surface. Evidence of root fatigue cracking was also found on Stages 2, 4, 6, and 11. Stages 7 and 9, and the one bent Stage 10 blade, were found to have tensile cracks at the root braze joints and tensile tears in some of the platform braze joints. Local burn spots on the spools showed evidence of severe overtemperature of the Inco 718 substrate. Four locations at Stage 11 and one at Stage 7 were confirmed cracked.

Based on the responsiveness of all stages of power turbine blading at first flexural frequency, it is concluded that the blade and spool design configuration did not provide effective dovetail Coulomb damping as anticipated. Hardware condition indicates that the Stage 1 blades were cracked to varying degrees prior to stall and that these cracks propagated in high cycle fatigue while sitting on point on October 2, 1985. As the cracks grew, the blades leaned further aft until one or more contacted Stage 2, causing the slow drop-off in propulsor rotor speed prior to the stall. Contact with Stage 2 rolled the leading edge, resulting in a sudden reduction in power turbine flow function. The reduction in flow function caused the F404 gas generator to stall. The remainder of the damage was secondary during the rapid shutdown.

All power turbine blades were replaced for Build 2. Spanning across adjacent blades, coulomb dampers (in the form of René 41 pins) were designed for all stages of blading as illustrated in Figure 3-14. Effectiveness of the damper design has been substantiated by component rig spin ("whirligig") and bench wear tests. Although no evidence of fatigue was indicated for the power frames, dampers were also added to Stage 12 as a precaution due to a predicted first flexural response with the outlet guide vane passing frequency. Strain gages have also been added to the Stages 5 and 12 power frame airfoils for Build 2.

Low cycle fatigue and crack growth analyses of the spools indicate that they have sufficient life capability for the remainder of planned testing. The spools have been weld repaired and the rub coats stripped and reapplied to provide additional margin.

Because of the severity of rub during Build 1 when oil leaked past the forward intershaft carbon seal and during the Build 1A stall, power turbine blade tip clearances have been increased an additional 0.050-inch on the outer attached blades and 0.030-inch on the inner attached blades, and all tips have been tapered to 0.005 to 0.015-inch thickness as a precautionary measure.

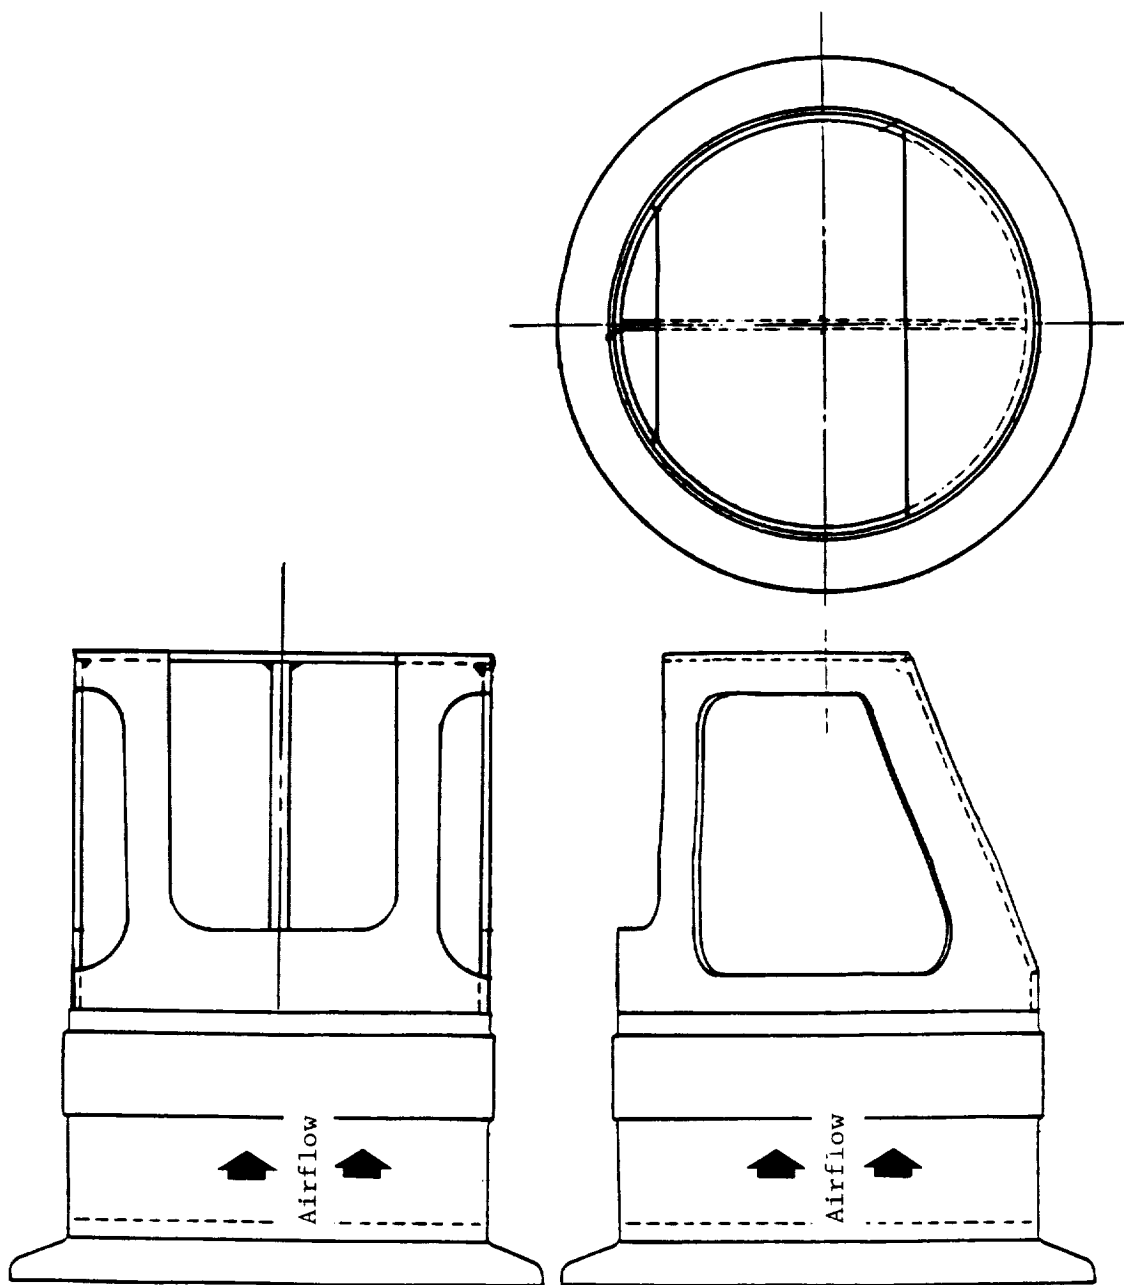
Figure 3-30. Redesign Bypass Bleed Valve Diffuser.

During Build 2, the fan bypass bleed valve diffuser failed in high cycle fatigue (Figure 3-29). Until a redesigned diffuser (Figure 3-30) could be

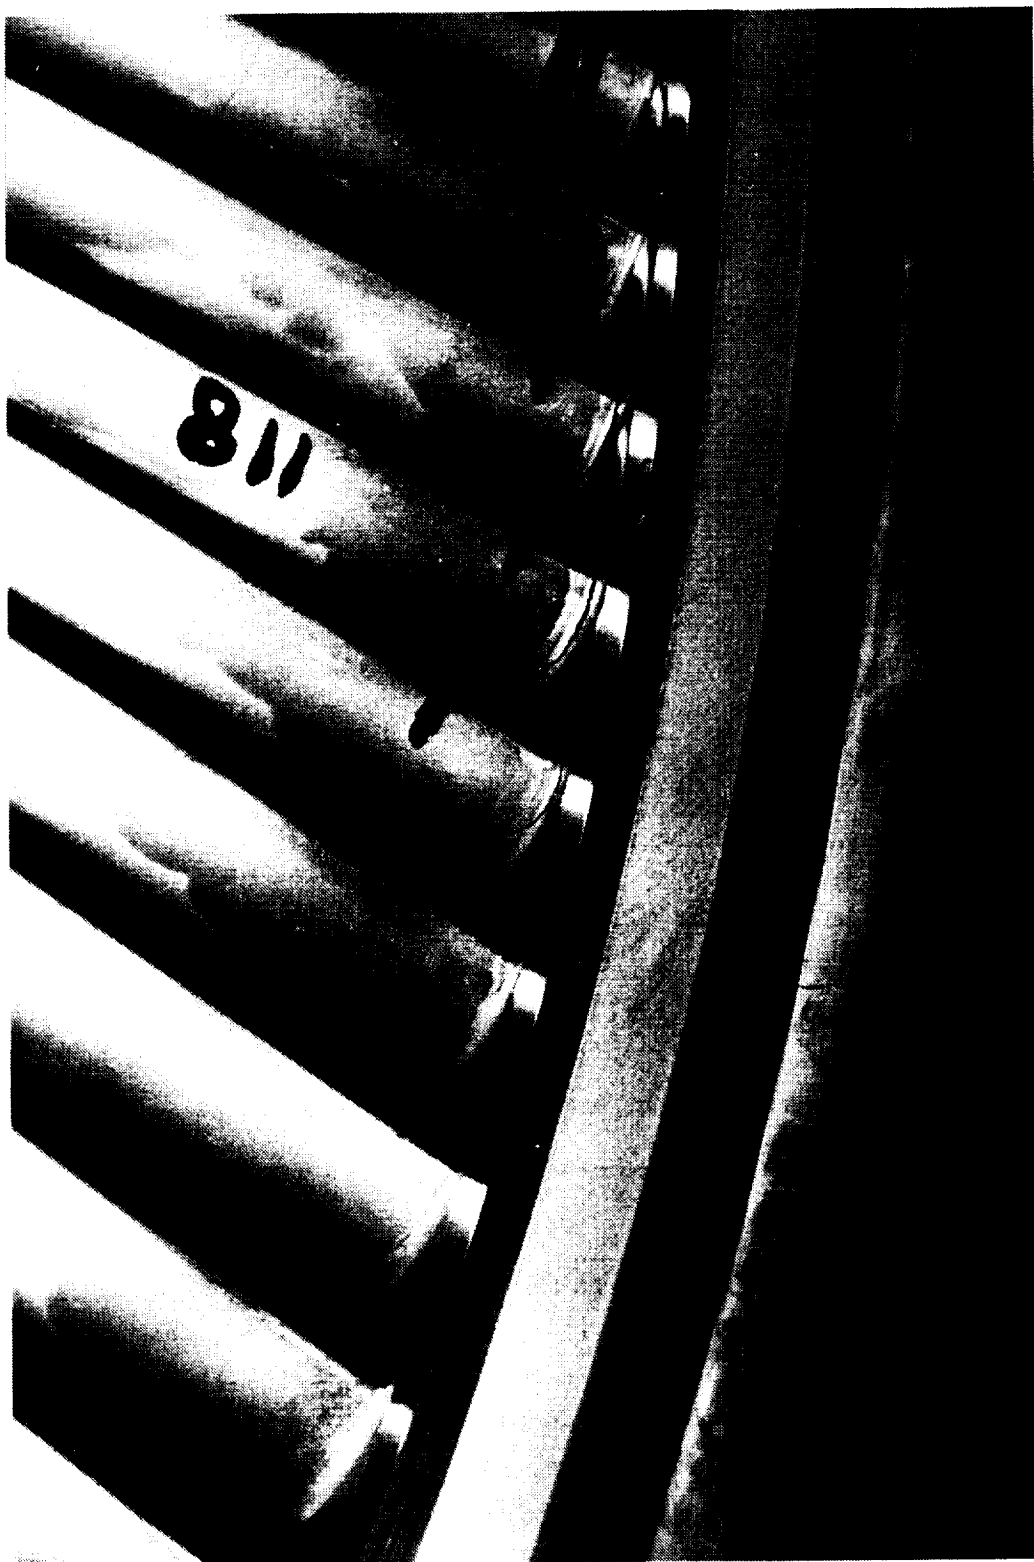
Figure 3-59. Stage One Blade Cracks at Leading Edge Root.

The Stage 1 blades were found to have HCF cracks that initiated at the leading edge root. The blades with the most visible cracks are illustrated in Figure 3-59. There is a total of 124 Stage 1 blades; of these, 19 blades had

Stage	1	2	3	4	6	7	8	9	10	11
No. of Blades	124	118	120	94	90	72	84	54	82	56
No. Cracked (1× Visual)	19	0	0	0	0	-	-	-	-	0
Additional No. Cracked (Borescope)	0	0	0	0	-	0*	0*	0*	0	3
Additional No. Cracked (10× Visual)	0	0	-	-	-	-	-	-	-	-
Additional No. Cracked (40× Visual)	34	-	-	-	-	-	-	-	-	-
Total Cracked	53 (42.7%)	0	0	0	0	0	0	0	0	3 (5.4%)
* Approximately 25% Sample; Others Inspected 100%

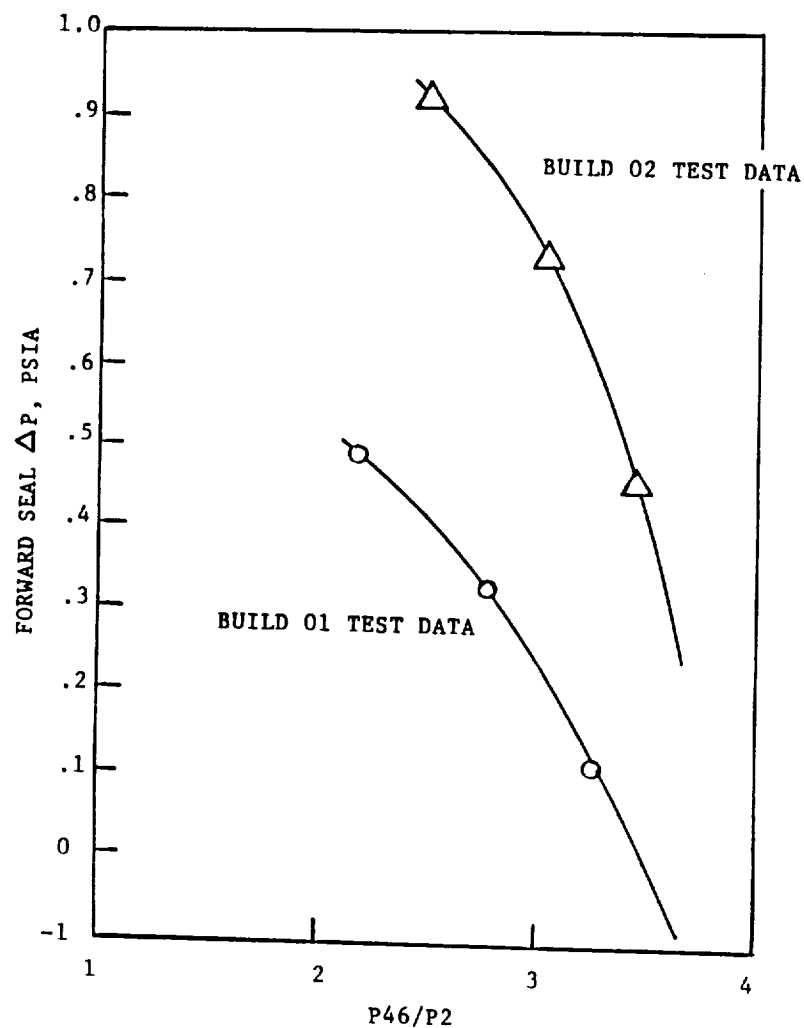
Figure 4-8. Potential Forward Seal Problem.

- PROBLEM: EXTRAPOLATION OF TEST DATA INDICATES THAT FORWARD SEAL COULD BACKFLOW AT MAX POWER.
- CAUSE: UNDERSIZED SUPPLY HOLE AND OVERSIZED ANNULUS HOLES REDUCE THE SEAL SUPPLY PRESSURE.
- SOLUTION: INCREASE SUPPLY HOLE AREA.

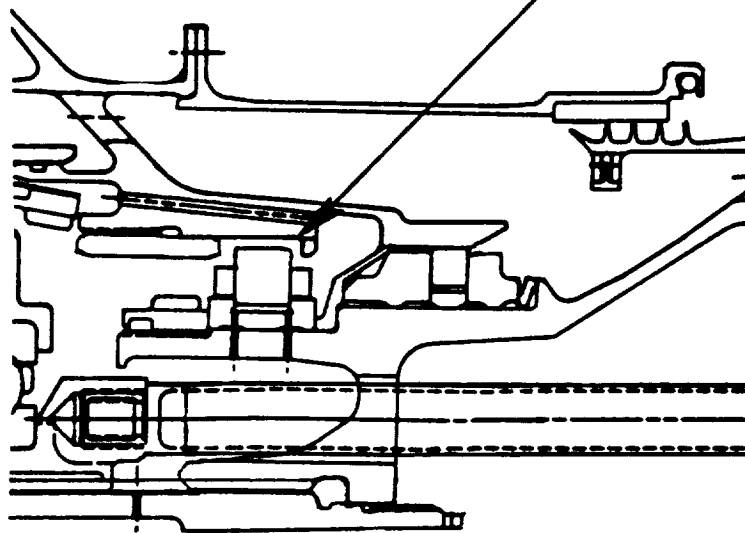
Figure 6-3. Disassembly Problem and Roller Corner Damage.

Rollers Having Moved Radially
Outward Contact Shaft Shoulder

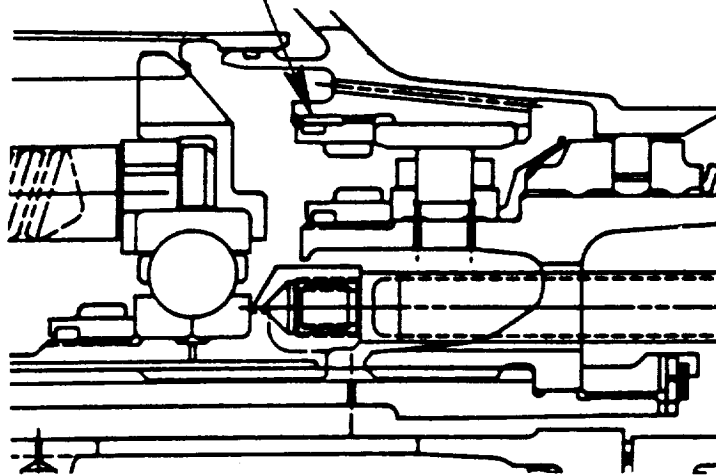
Figure 6-4. Problem Solution - Positive
Nut Locking.

Axial Roll Pin
Welded in Place

For subsequent engine testing, a hole was line-drilled axially in the thread, and a roll-pin was mechanically locked in the thread to prevent the nut becoming untorqued (Figure 6-4).

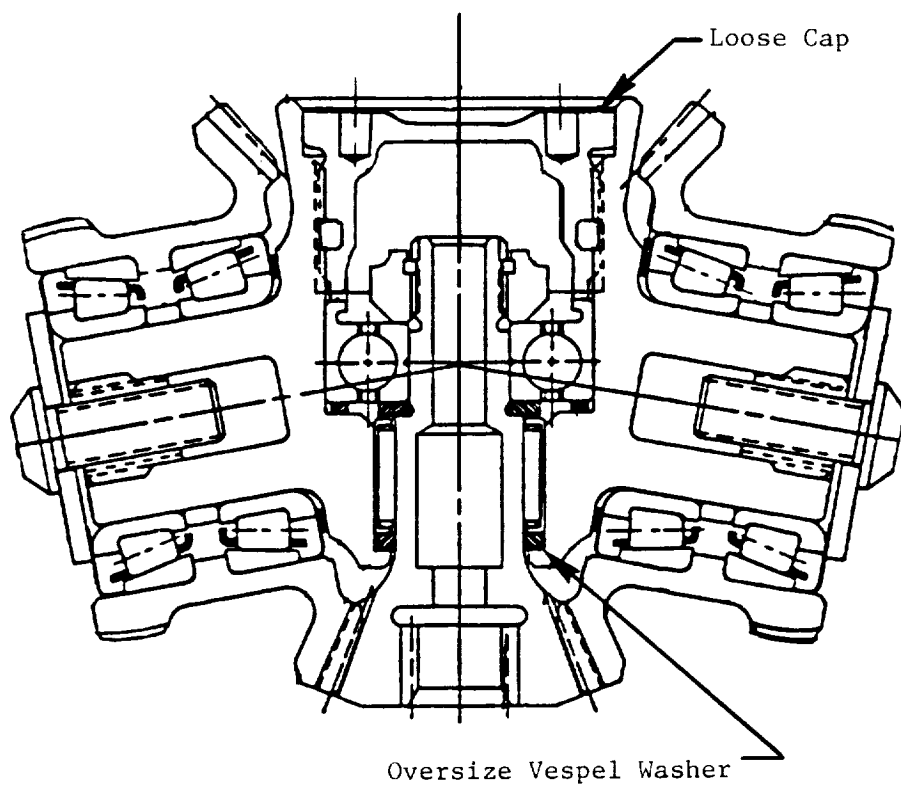
Figure 6-5. Gearbox Stackup Problem Causing Incorrect Loading of Ball Bearing and Cap Looseness.

The setup bearing is incorporated to react the blade overturning moment and carry most of that load. However, at speed, the centrifugal load is sufficiently high that a very large moment would be required to unseat the main
